ASSESSMENT OF THE GEOMORPHOLOGICAL AND SEDIMENTOLOGICAL CHANGES IN MAMAIA SECTOR AFTER THE IMPLEMENTATION OF THE COASTAL PROTECTION MEASURES

The paper analyses the changes in the beach sector of Mamaia resort from a geomorphological and sedimentological point of view in the context of coastal protection works carried out in 2014-2015 and 2021 (measures to reduce wave energy, beach protection with structures to stabilize the sand and beach nourishment). The Mamaia sector, with a length of about 12 km, is geomorphologically constituted mainly by sandy barrier of Lake Siutghiol representing a transition unit between the northern unit (deltaic and lagoon shore) and the southern unit (small pocket rocks-beaches in front, separated by small coastal sandbars). From an economic point of view, the sector is important for coastal tourism both in terms of the number of tourists and the existing of infrastructure generating significant revenues. Since the 1950s, the sector has been severely affected by the construction of the dikes of the Midia Port in the north, which have affected the longitudinal transport of sediments and accentuated the erosion of the submerged and backshore beach. To co

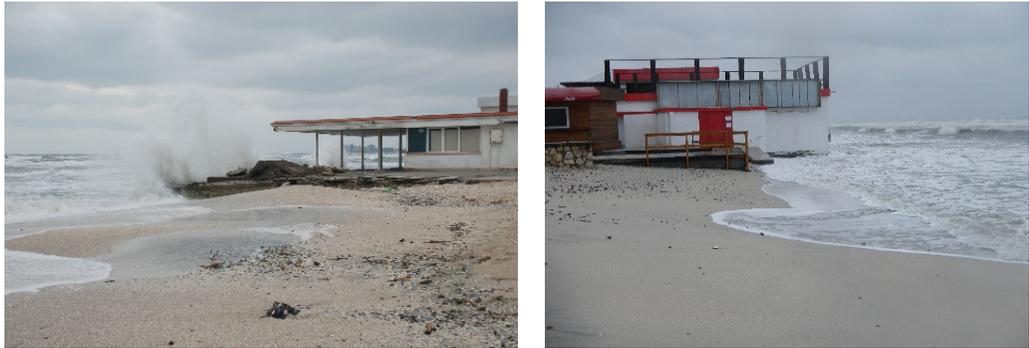
Fig. 2. Profile 10 before nourishment (2013)

In some parts (near profile 10), the beach has diminished a lot due to coastal erosion so, during severe storms, the tourist beach was almost completely flooded and the tourist infrastructure was in danger of destruction (Fig. 2 and Fig. 3).

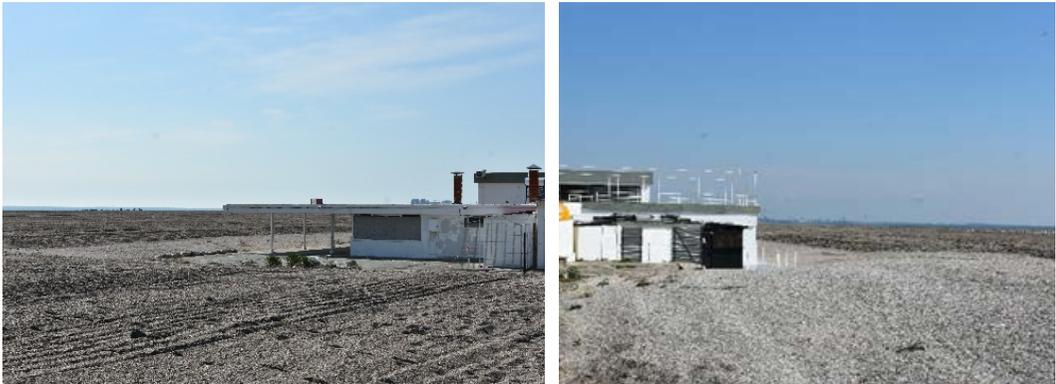
Fig. 3. Profile 10 after nourishment (2022)

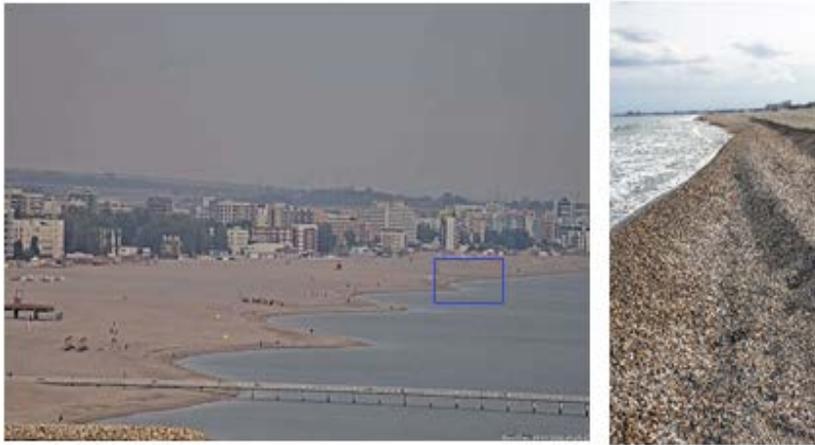
Fig. 4. Shoreline shape under the influence of wave action

The shoreline emphasizes the conditions for a sharpened slope for the beach-face in the area of the cusped features (Fig. 4) induced by the parallel breakwater protection system within five months. The beach profile observed from a lateral image reveal a sharp slope of the submerged beach as well, due to the new equilibrium profile determined by a coarser type of sediment of the borrowed material of the nourishment.

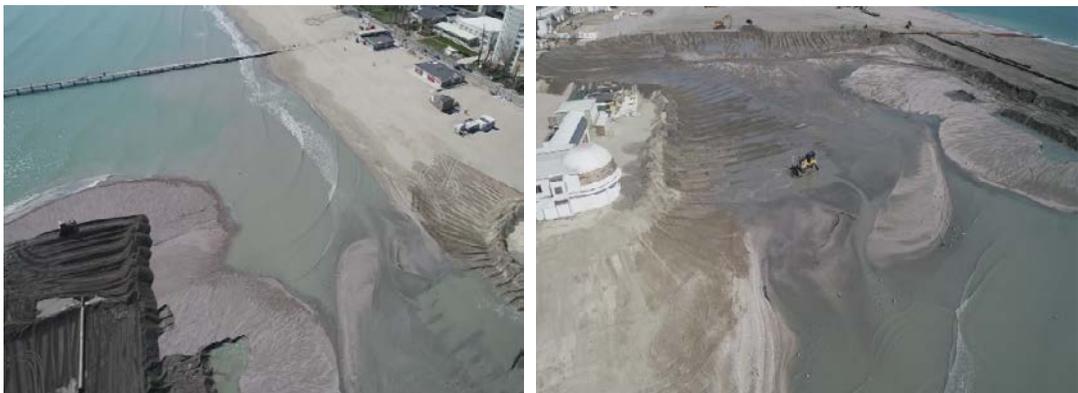
Fig.5. Artificial sanding, Mamaia center sector

At the time of its execution, the nourishment solution for the beach protection was extended by hydraulic mechanization (pumping) (Fig.5), it was considered the decompensation action of the wind that transfers the fine sand outside the beach, thus made certain stabilized dune around the vegetation limit, but the lifetime period of the extended beach was 50 years.
