A Short and Long Term Evaluation of along Shore Geomorphological Changes in the Danube Delta <i>(Alina-Daiana Spînu, Emanuela-Maria Mihailov, Luminița Buga, Dănuț Diaconeasa)</i>	“Cercetări Marine” Issue no. 48 Pages 161-170	2018
--	--	-------------

A SHORT AND LONG TERM EVALUATION OF ALONG SHORE GEOMORPHOLOGICAL CHANGES IN THE DANUBE DELTA

Key-Words: shoreline, morpho-dynamics, Danube Delta, coastal protection

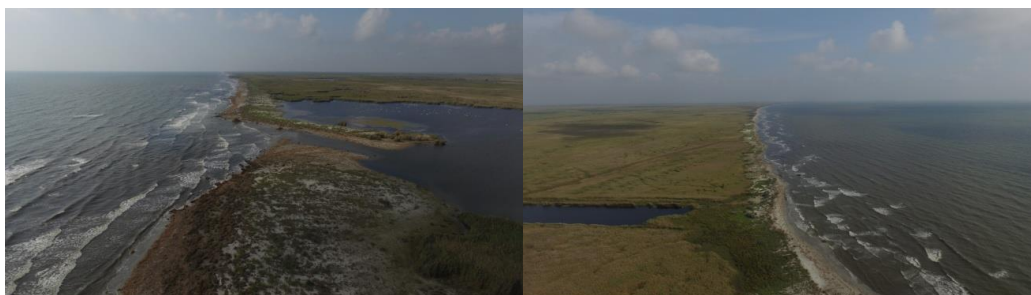
Fig. 2. Garla Împușitei - Câșla Vădanei sector.

of the sector, between Garla Imputita and the Cazacu sandbank, about 10 km, the shore is fragile, consisting of fragments of coastal belt with a height of 0.5-0.6 m and width not exceeding 30 m (Diaconeasa, 2009). In many sectors reeds and reed islets fixed to the ground get close to the shoreline, being washed away by the waves. In this sector, in periods with high levels of the Danube waters, forms the numerous breaches, the delta drainage into the sea (Fig. 2).

The annual erosion rates calculated showed an average of $\sim 5\text{-}20$ m/year. Between 1975 and present, the erosion process of the beach is particularly intense, the shore being over 600 m in certain sectors.

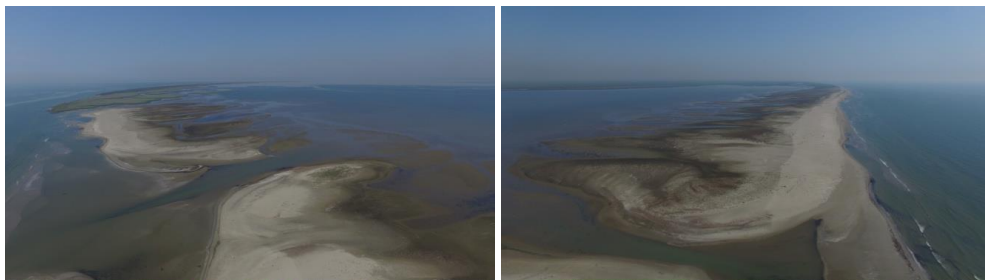
Fig. 4. Sahalin peninsula (aerial images, 2017).

The sector is vulnerable from morphologically point of view, the shore on ~3 km being destroyed by extreme storms during the cold season in 2013, currently undergoing a recovery process (fig 4, fig. 5).

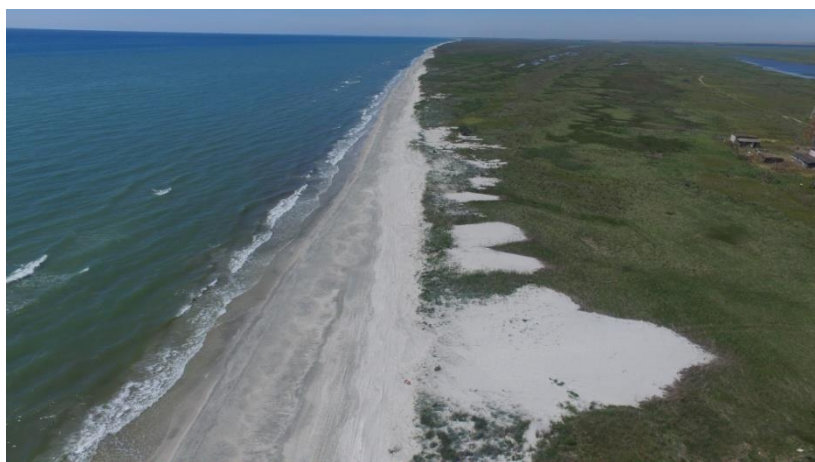
Fig. 8. Photo of the Chituc sandbank.

The Chituc sandbank (Fig. 8), with a length of approximately 20 km, was formed by the joining of several successive coastal belts in the direction of the ENE-WSW. The erosion occurs in the northern part of the sector, and continues ~10 km to the south (Spînu, 2017). In the southern part of the sector, the shore becomes typically accumulative, with broad beaches and sand dunes, the shoreline advancing between 1962-2017 with approx. 4-5 m/year.

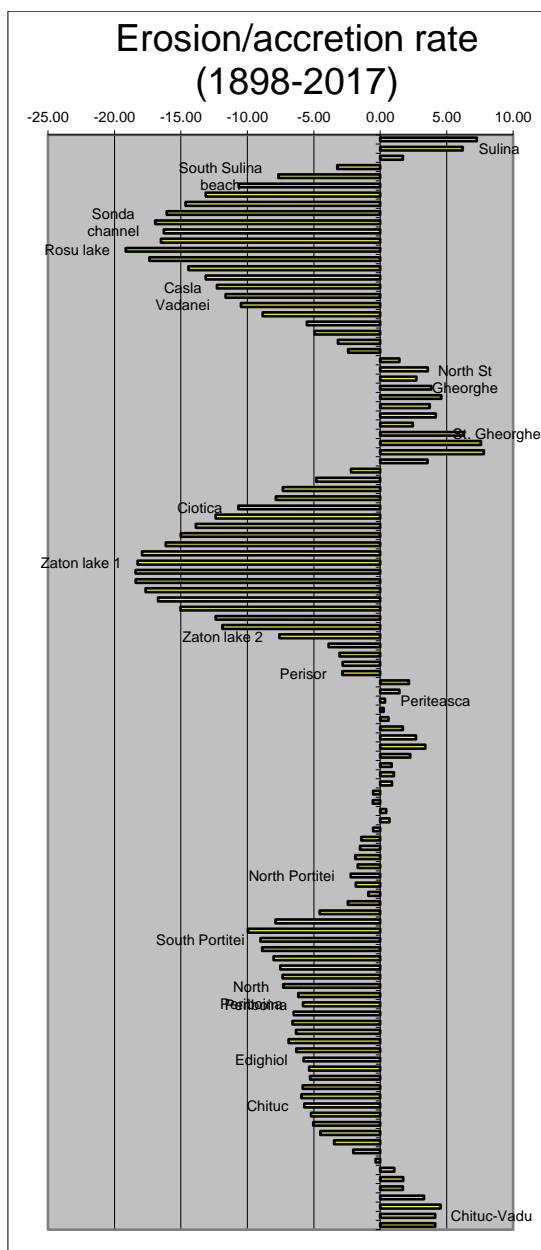
Fig. 9. Erosion/accretion rate (1898-2017).

Historical climate changes and especially recent changes induce important modifications in the shore configuration. Sea level rise and the intensification of meteorological and hydrological extreme phenomena due to climate change and in direct association with the decrease of sedimentary material transported by the Danube, coupled with modifications of sea currents, have resulted in pronounced erosion of the shores, the deltaic and lagoon sector being the most affected (Fig. 9).
